**ADDENDUM NO. 1**

**FY26 Stormwater Improvements**

City of Seminole

**SUBJECT:** Geotechnical Investigation – Roadway and Groundwater Assessment  
72<sup>nd</sup> Terrace North, Seminole, Pinellas County, Florida

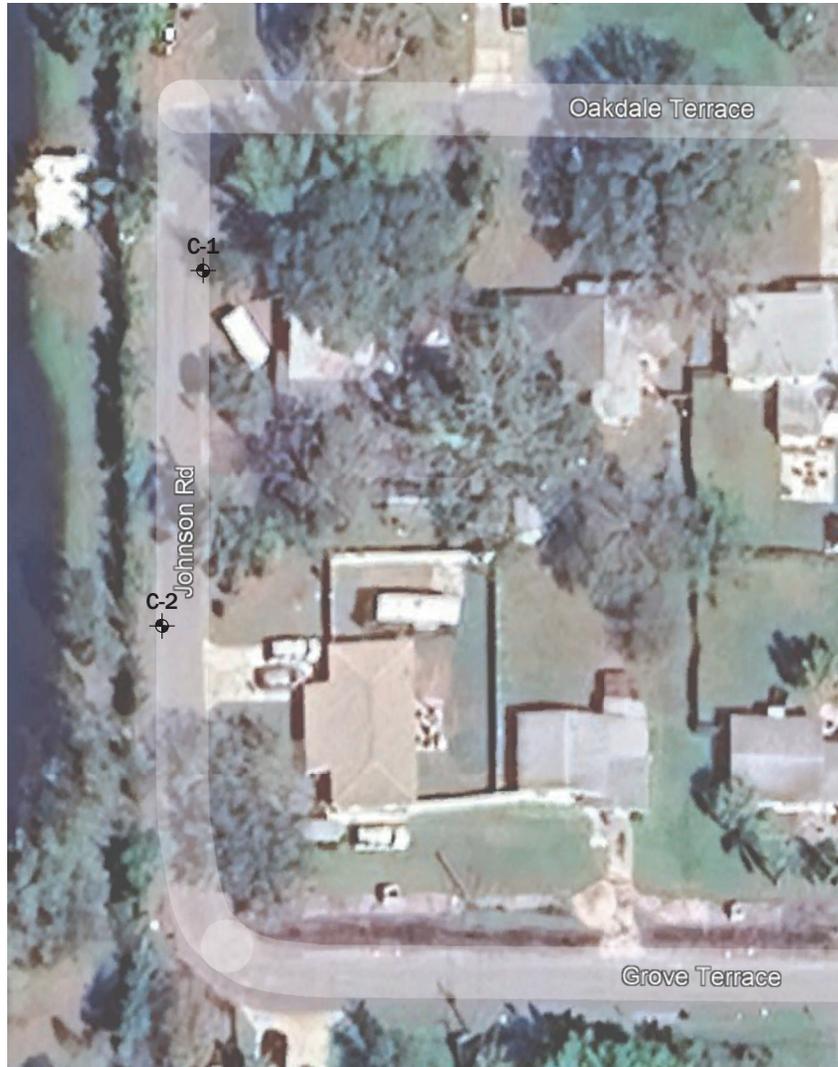
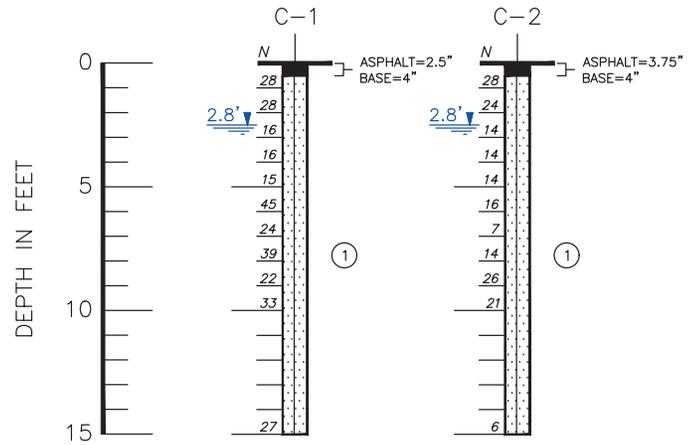
<b>Andreyev Engineering, Inc.</b>		GEOTECHNICAL INVESTIGATION <b>STORMWATER DRAINAGE IMPROVEMENTS</b> GROVE TERRACE & JOHNSON ROAD SEMINOLE, PINELLAS COUNTY, FL	
		BORING LOCATION PLAN/ SOIL PROFILES	
APPROXIMATE SCALE: AS SHOWN	DATE: 11/10/25 PN: APGT-25-153	ENGINEER: AD DRAWN BY: DLS	FIGURE 1

Based on the results of the SPT borings, the soil conditions generally consist of fine sand with variable amounts of silt. The soils encountered beneath the pavement base layer and extending to the boring termination depths of approximately 15-feet below the pavement surface were described as fine sand to slightly silty fine sand (Stratum 1). The sandy Stratum 1 soils were given the American Association of State Highway and Transportation Officials (AASHTO) classification of A-3. Based on SPT "N"-values taken from our SPT borings, the granular (sandy) soils

The shallow groundwater table was encountered at depths of approximately 2.8 feet below the pavement surface at the time that the cores/borings were performed. The groundwater levels measured at the time of drilling are presented adjacent to the boring profiles on **Figure 1**.

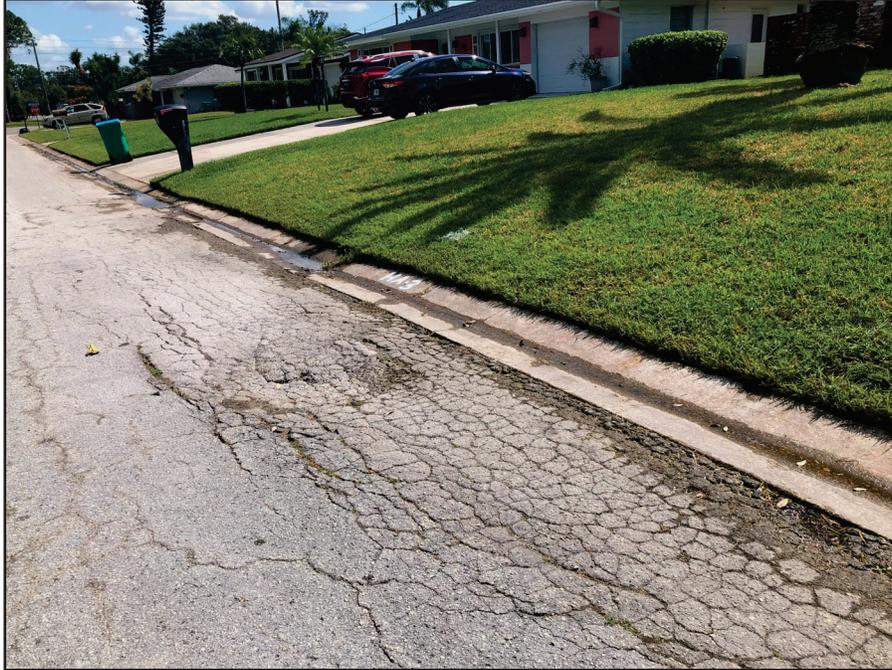
The observed pavement distress, seepage, and oxidation stains on the curbs generally correlated to the area delineated by the Immokalee Soil Map Unit with an estimated seasonal high groundwater level of 6 to 18 inches below the ground surface. While the anticipated high ground water level would not be expected to breach the ground surface in the natural condition, we noted that the ground surface at the residences on the adjacent properties extended above the elevation of the roadway crown. Additionally, the properties along the south side of the roadway were notably higher than the roadway with moderate downward slopes towards the curb. The more prevalent areas of stand water and seepage on the pavement/curbs corresponded directly to the higher properties. Thus, the observed conditions were consistent with a relatively high natural groundwater level in the soils, and the subsequent seepage at the back of the gutters along the lower-lying roadway.

**Photograph 1:** View of an area of extensive distress to the asphalt pavement along the subject portion of 72<sup>nd</sup> Terrace North in Seminole, Florida.

In regard to potential mitigation efforts to lower the groundwater levels in the vicinity of the roadway alignment, a properly designed and installed underdrain system can effectively intercept the high groundwater adjacent to the roadway alignment and lower the groundwater level beneath the pavement section. The Florida Department of Transportation (FDOT) Standard Plans – Index 440-001 can be used as a guide for underdrain installation, particularly Type I, II, or III assemblies. The underdrain system will require periodic inspection and maintenance to ensure proper function and long-term performance.

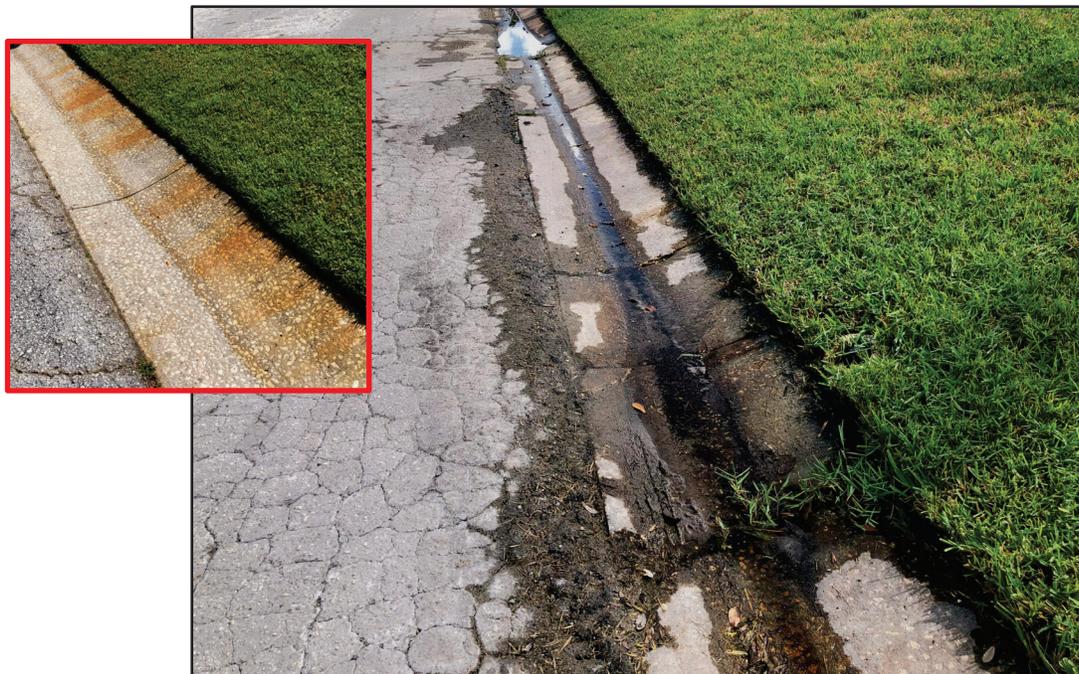
In addition to the assessment of the soil and groundwater conditions documented during our evaluation, we observed that the majority of the properties along the subject portion of the roadway alignment exhibited irrigation components, particularly irrigation heads directly adjacent to the curbs. We further noted while performing the hand augers, the soils encountered above the groundwater level were wet or saturated, including the topsoil layer of the turf grass lawns. The presence of irrigation components, in conjunction with wet conditions in the surface soils above the encountered groundwater level, indicated that irrigation (and possible over-irrigation) of the residential lawns has contributed to the high groundwater conditions and the subsequent seepage at the back of the curbs.

**Photograph 2:** View of a typical area of seepage from the soils adjacent to the concrete curb, as well as oxidation stains on other areas of the curbs (inset).

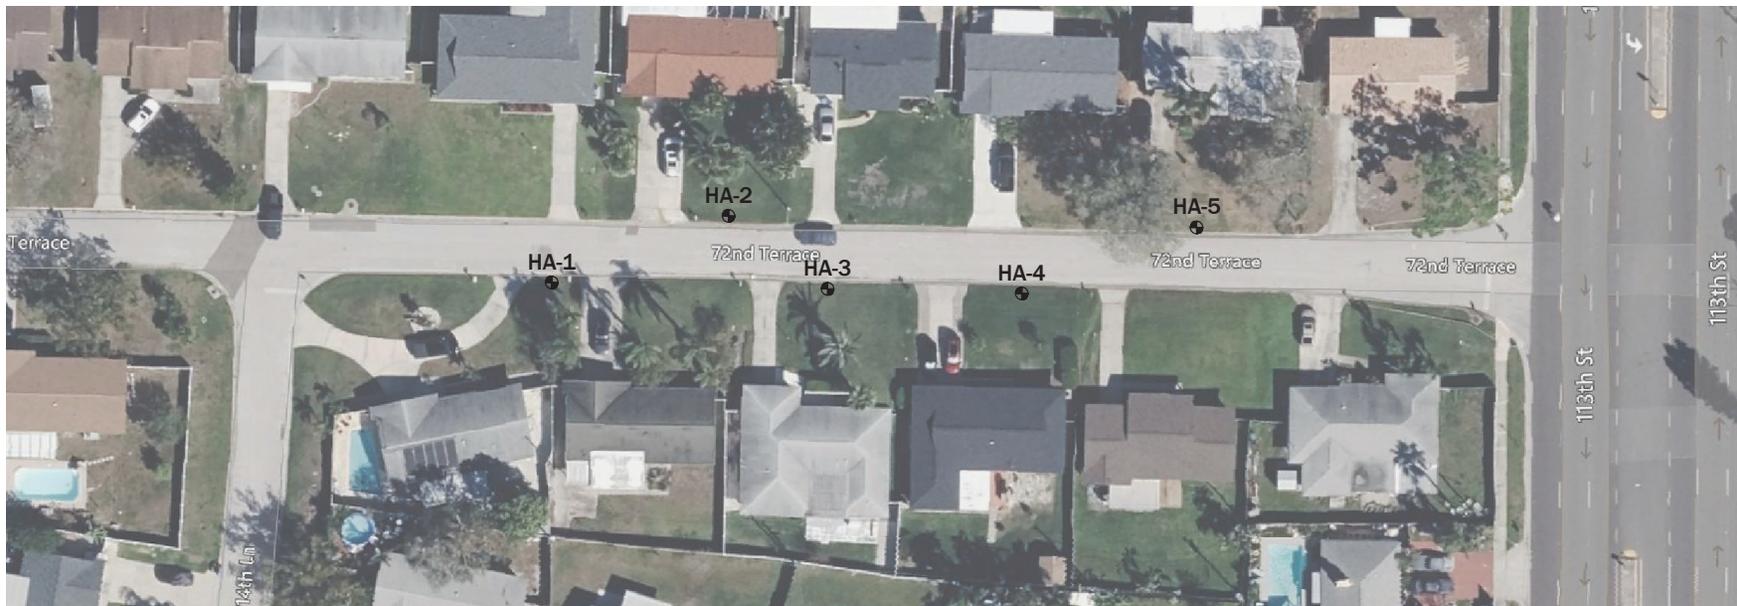
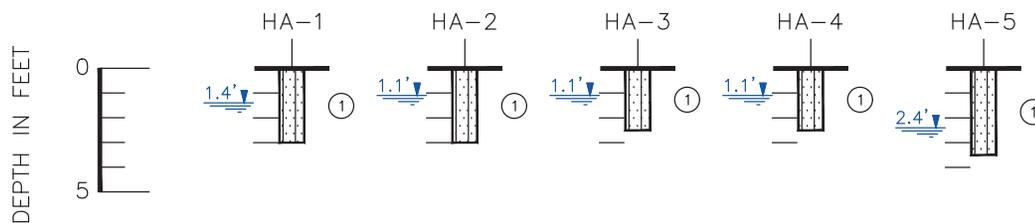
FIGURE 2

as deep as practicably possible to depths of approximately 2.5 to 3.5 feet and were terminated when the sandy soils around the boreholes collapsed due to the inflow of groundwater. Representative samples of the encountered soils were collected and transported to our laboratory for verification of the field classifications. The borings generally revealed a thin layer of topsoil associated with the turfgrass lawns, followed by fine sand soils with trace amounts of silts. The groundwater levels were recorded following an approximately 1 hour stabilization period, which ranged from about 1.1 to 2.4 feet below the existing ground surface. The subsurface conditions encountered in the soil borings were generally commensurate with the soil properties and characteristics described for the Immokalee Soil Map Unit. Hence, we ascertain that **the observed pavement distress, as well as the wetness and stains along the concrete curbs were consistent with seepage from natural seasonal fluctuations in the groundwater levels within the soils adjacent to the curbs and beneath the asphalt pavement section.**
